**Flood Control Project Maintenance
Levee Inspections**

Maintenance Issue Types Only, Levee Inspection Report By Mile - Spring 2018

Sutter Maintenance Yard Murphy Slough at M&T Ranch

Waterway	Bank	Unit Miles	Inspection Start/End	Inspector
Unit No. 01 Murphy Slough at M&T Ranch	Left	0.83	03/08/2018 03/08/2018	Bob Duffey

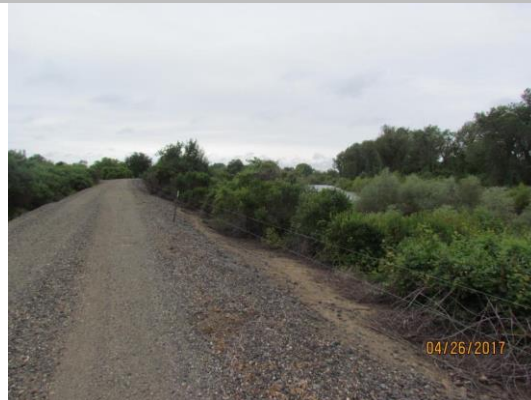
Photo 1 of 1 : SP_2018_ST0014_372_1_20180305_00001.jpg

LM Start	0.00	Rating **	M	Issue No.	1
LM End	0.09	Issue Type +	Ma	Location *	WS
Category	Earthen Levee			GPS Latitude/Longitude	
				Start	End
Item	Vegetation			39.667534 °	39.666836 °
				-121.959612 °	-121.960897 °
DWR ID	DWR_NA0014_01_s _ 2012_1				
Comment Code					
V4 : Elderberries are blocking visibility and flood fight capability.					
Inspector Comment

View of the elderberries along the waterside toe.

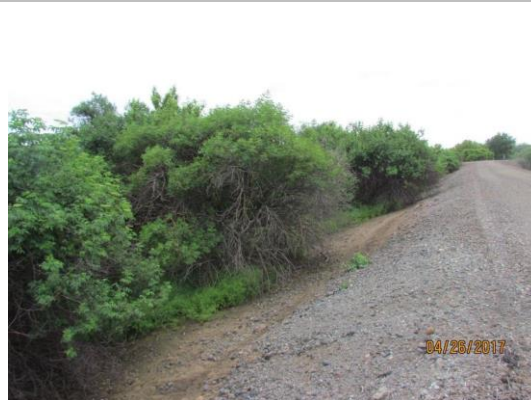
Photo 1 of 1 : SP_2018_ST0014_372_4_20180305_00002.jpg

LM Start	0.00	Rating **	M	Issue No.	4
LM End	0.09	Issue Type +	Ma	Location *	LS
Category	Earthen Levee			GPS Latitude/Longitude	
				Start	End
Item	Vegetation			39.667708 °	39.666983 °
				-121.959817 °	-121.960997 °
DWR ID	DWR_NA0014_01_s _ 2012_4				
Comment Code					
V4 : Elderberries are blocking visibility and flood fight capability.					
Inspector Comment

View of the elderberries along the landside toe.

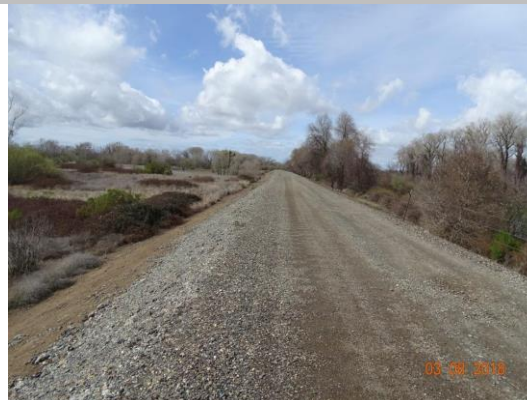
Photo 1 of 1 : SP_2018_ST0014_372_5_20180312_00003.jpg

LM Start	0.11	Rating **	A	Issue No.	5
LM End	0.83	Issue Type +	Ma	Location *	LS
Category	Earthen Levee			GPS Latitude/Longitude	
				Start	End
Item	Vegetation			39.666822 °	39.670685 °
				-121.960913 °	-121.970463 °
DWR ID	DWR_ST0014_01_s_2018_5				
Comment Code					
V1 : Control annual grass and weeds on the levee slopes and easements.					
Inspector Comment					
There is no vegetation on the levee slope.

View of the both levee slopes with no vegetation.
